Object name

Client:  
Location:  
Installed power:  
Inspection:  
Report date:  
Report type: Thermal drone report

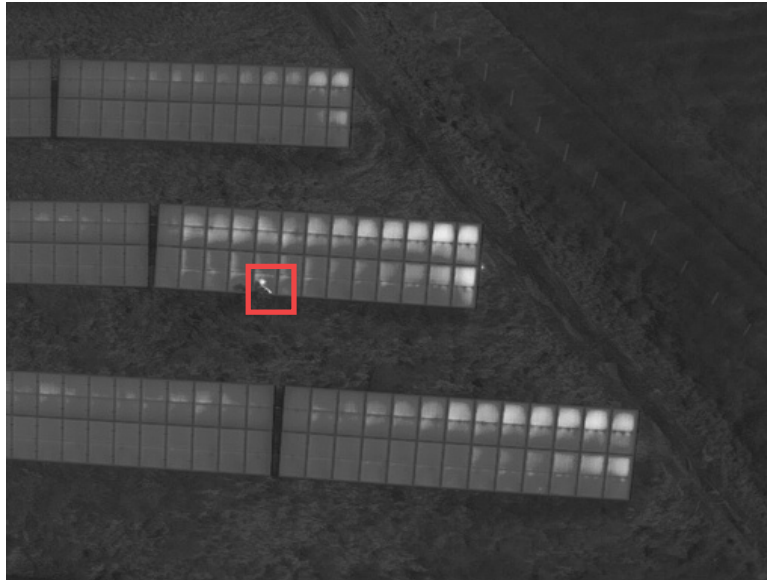
## 4ccedc — Unknown anomaly

Category: Unknown anomaly

Priority: Medium

Thermal drone image

Perform a visual inspection and electrical measurements on site; determine the cause after diagnostics.

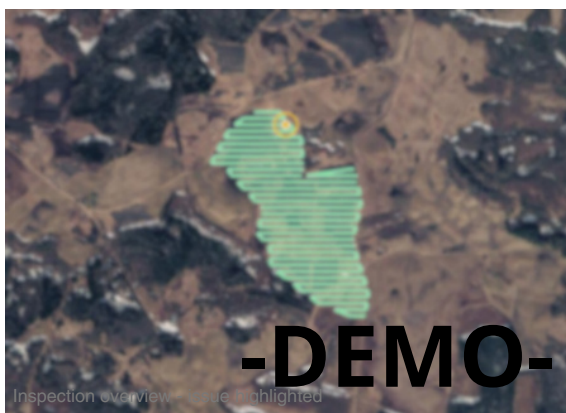
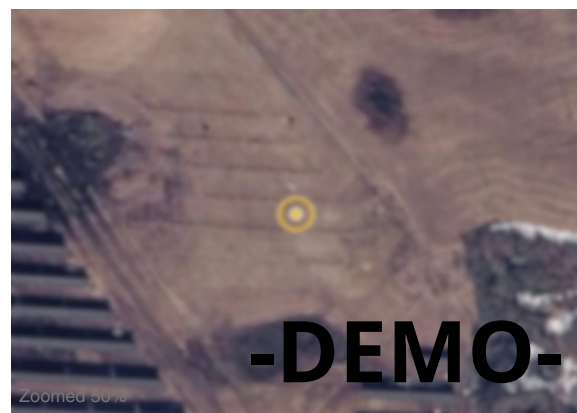
Inspection overview - issue highlighted

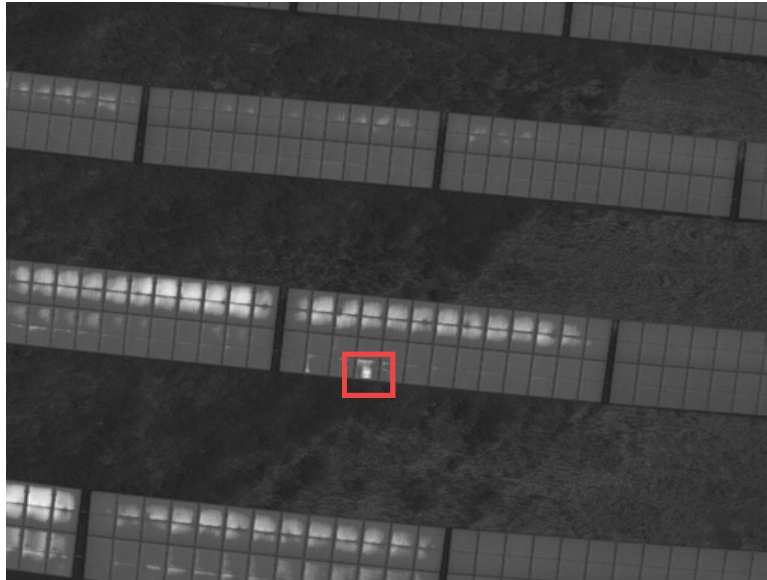
## 85d640 — Hot spot

Category: Hot spot

Priority: Medium

Thermal drone image

Inspect the module on site and take electrical measurements; replace the module if damage is confirmed.

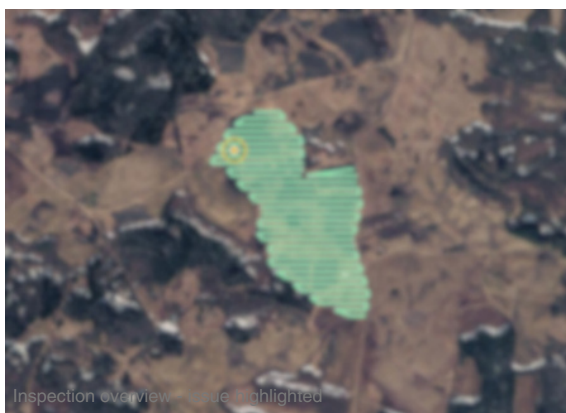
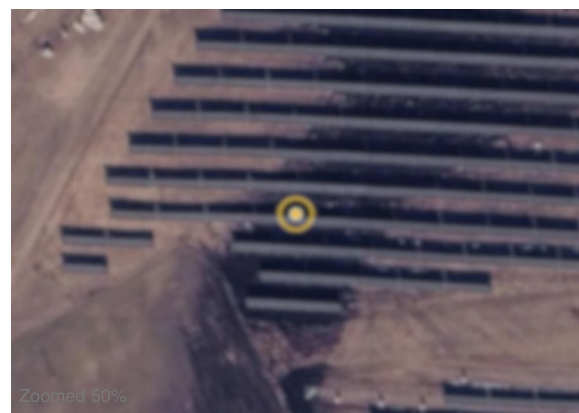
Inspection overview - issue highlighted
